UM-3710-98
1998 GMC Suburban

In-depth
Vehicle
Occupant
Report

The University
of Michigan
Transportation
Research Institute

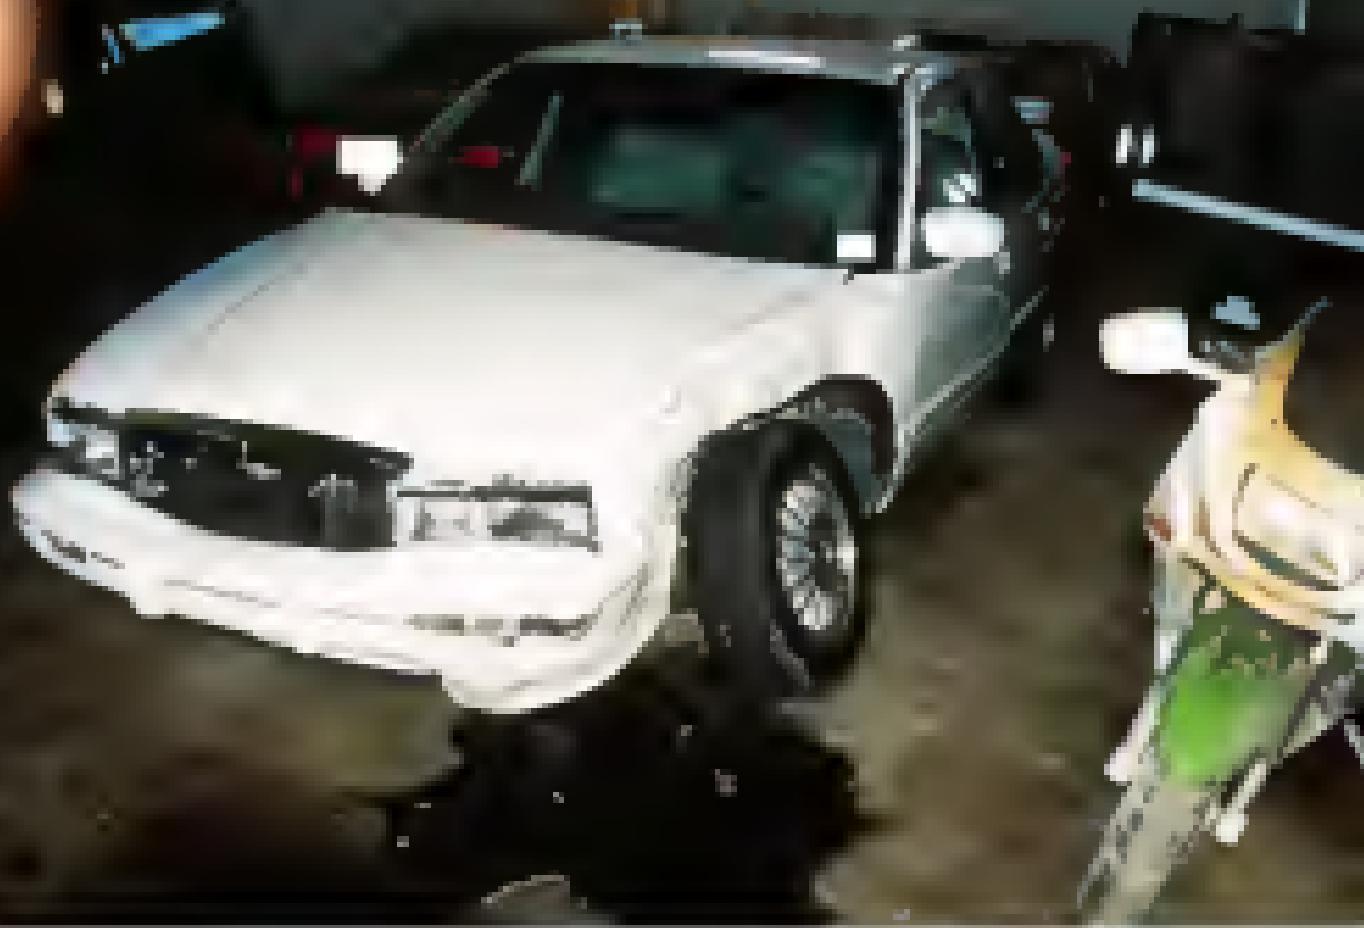
PN 3710-98 #5

(Slide 5) Damage to vehicle (B) was moderate. The maximum crush was 19 cm to the left-front fender just in front of the left wheel.

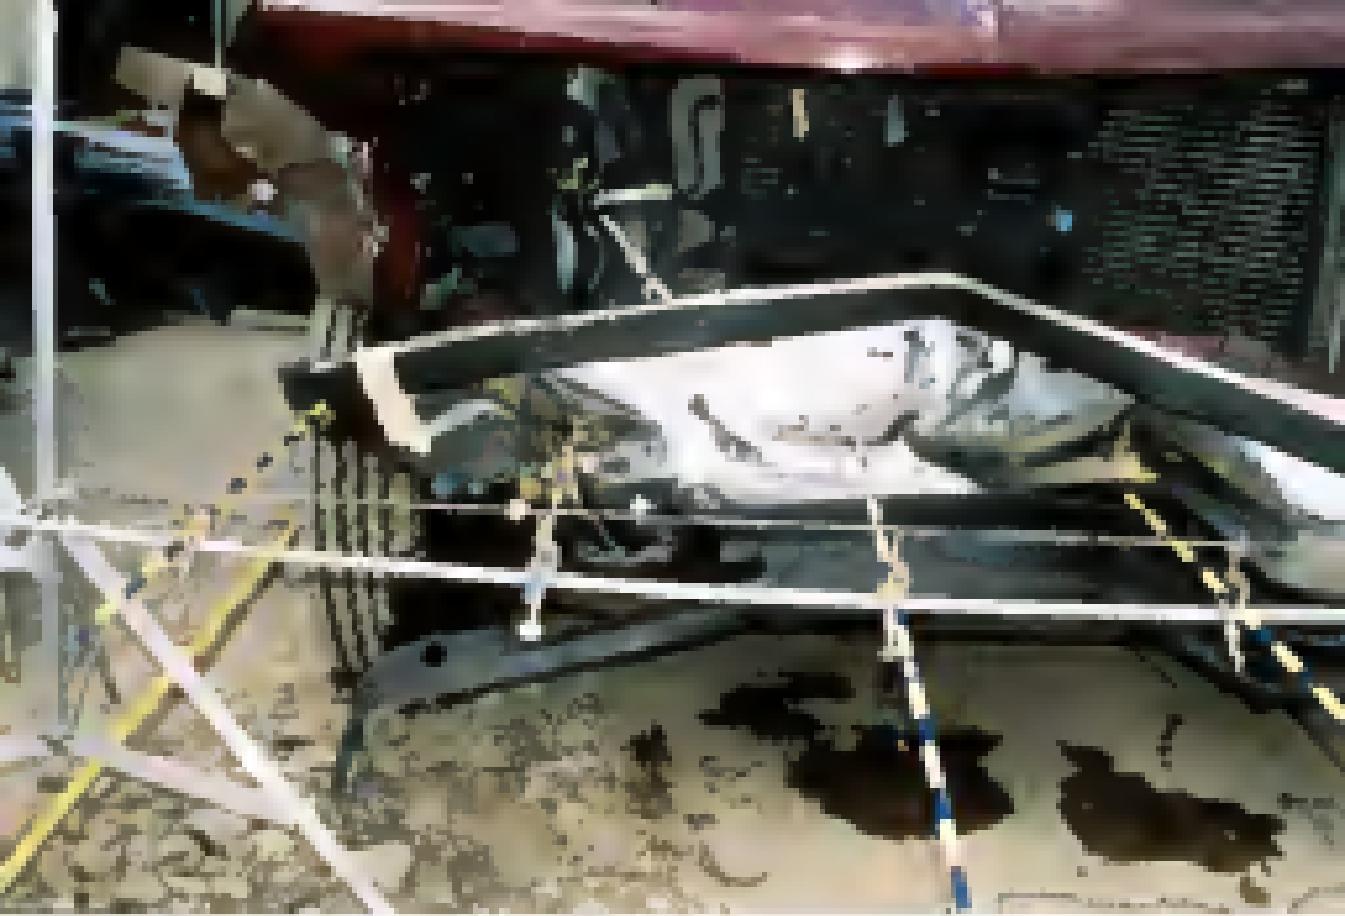
PN 3710-96 #13

(Slide 12) Damage to case vehicle (A) was moderate. (Slide 13) The maximum crush was 31 cm to the right-center of the front bumper. (Slide 14) Using the undamaged portion of the front bumper (74 cm) and an undeformed end width (UEW) of 180 cm, the front-end overlap was calculated to be 59 percent. The vehicle overlap was calculated to be 58 percent using the overall width of 195 cm.

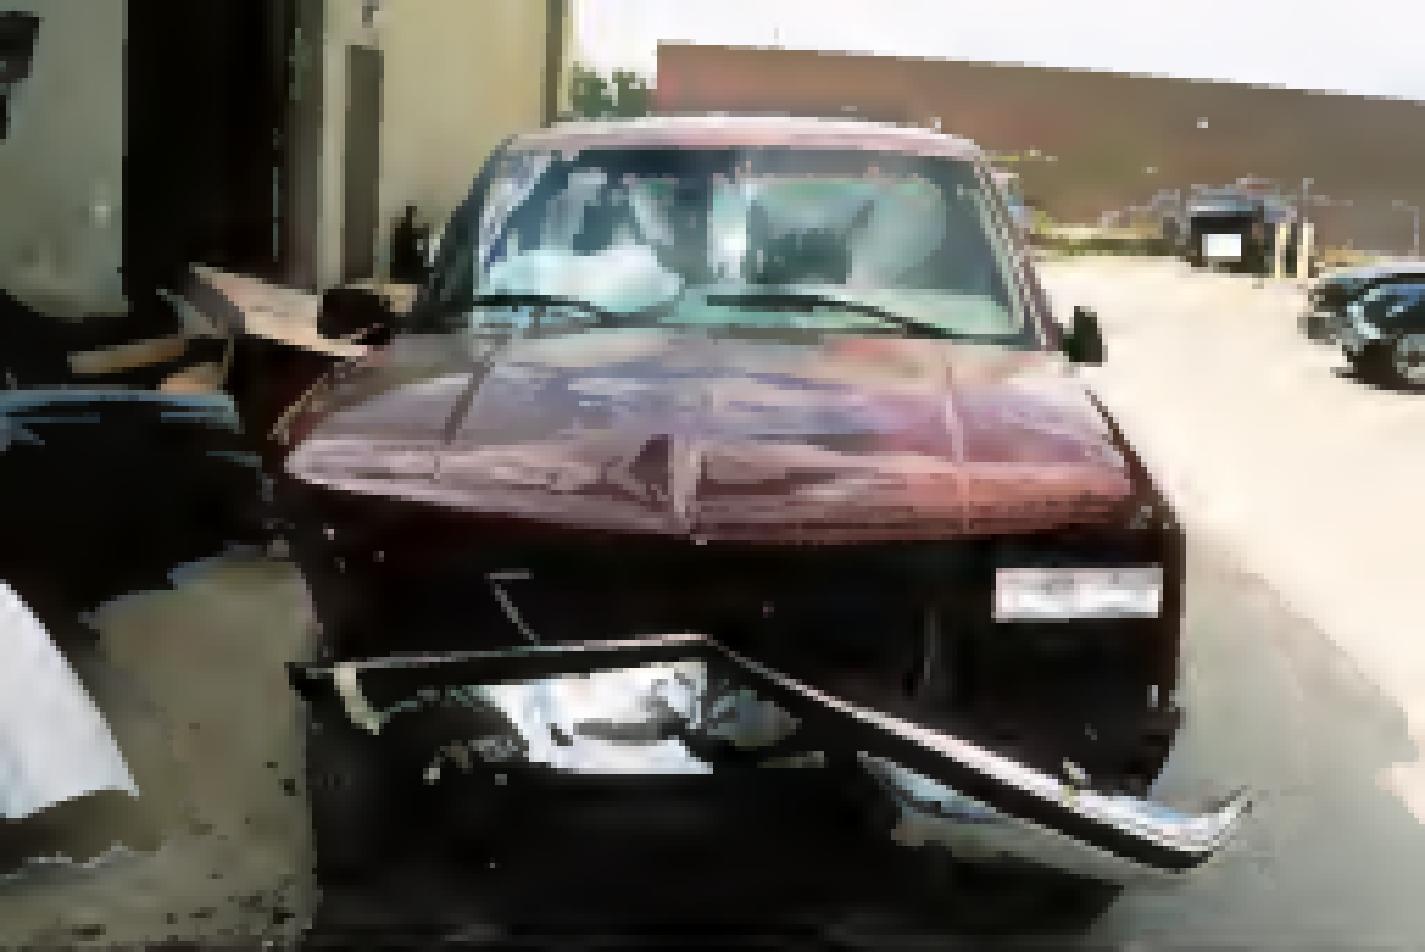
PN 3710-98 #15

In the front, (slide 15) the grille, right headlight assembly, hood, and hood latch were damaged, the hood latch was jammed closed (pried opened by the body shop), and the rear edge of the hood was elevated, but it did not contact the undamaged windshield. (Slides 16 and 17) The engine compartment was damaged. On the right side, (slide 18) the front fender was damaged, and the front tire was flat, (slide 19) but there was no significant change in the wheelbase. On the left side, (slide 20) the front fender was damaged, but there was no significant change in the wheelbase. (Slide 21) There was no damage to the rear of the vehicle.

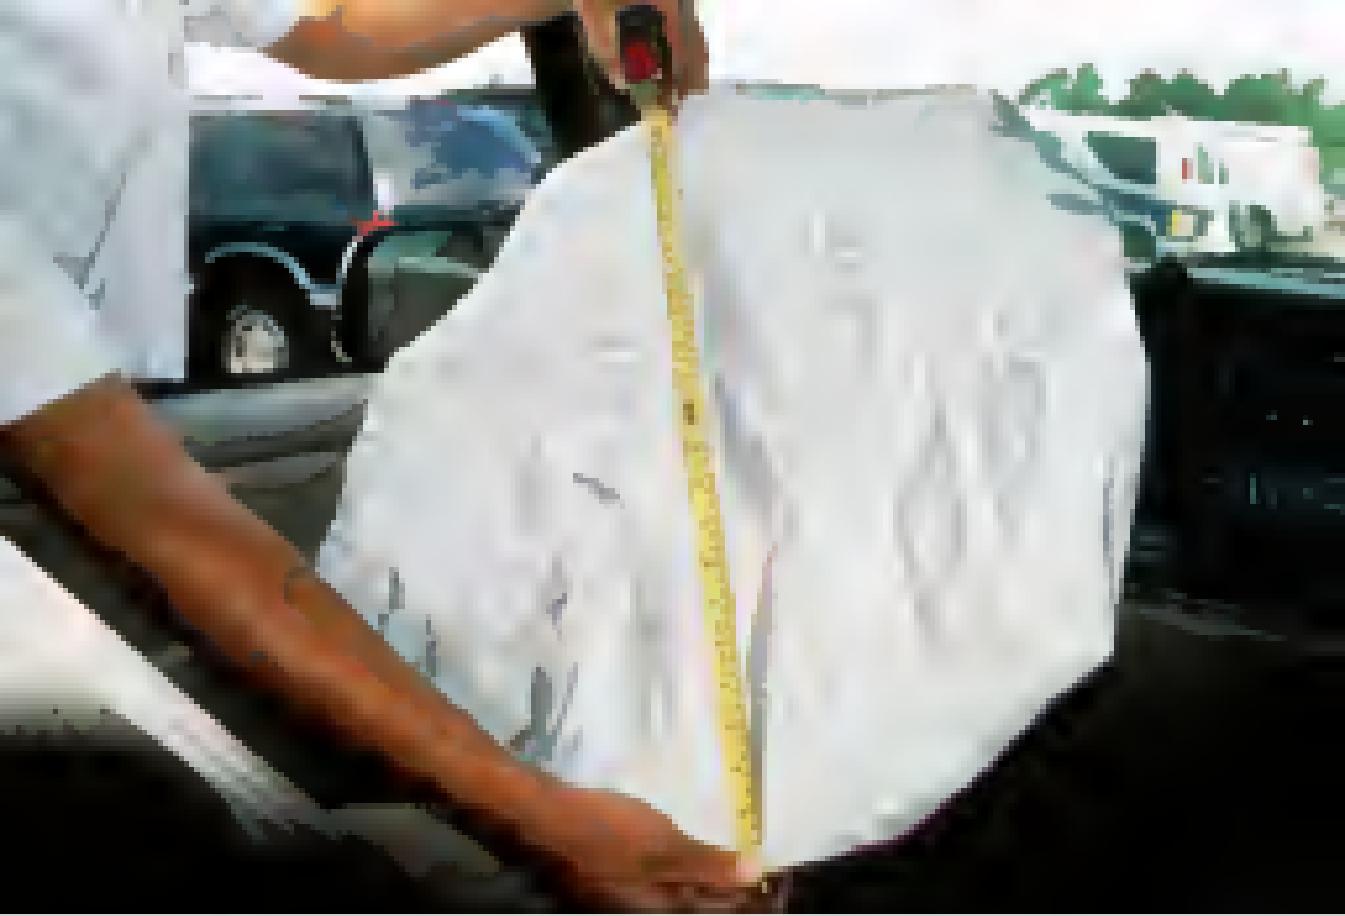
PN3710-96 #23
Best Available

(Slide 23) This vehicle was equipped with steering-wheel and (slide 24) passenger frontal-impact airbags, which deployed. (Slides 25, 26 and 27) There was no damage to the steering-wheel rim or spokes, and no apparent rotation of the steering column. (Slides 28, 29, 30, 31, 32 and 33) There was no apparent damage to the interior.
